Case Vehicle (A): 1998 Mercury Type: Mystique GS, 4-door sedan

Vehicle (B): 1999 Toyota Type: Camry LE, 4-door sedan Driver: 22-year-old female

#### **SITUATION**

# GENERAL VEHICLE DAMAGE AND ESTIMATED CRASH SEVERITIES

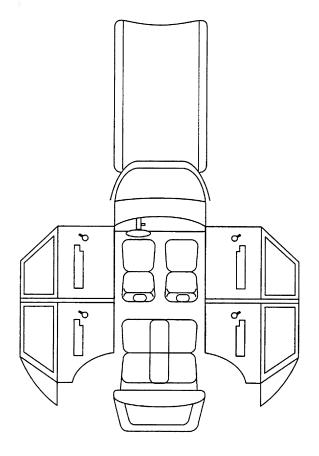
### VEHICLE OCCUPANT CONTACT DIAGRAM

Confidence
	Interior	Occupant	Body		Level of
	Component	No. if	Region		Contact
Contact	Contacted	Known	if Known	Supporting Physical Evidence	Point
Α	knee bolster	1	knee	scuff mark	1
В					
С					
D					
E					
F					
G					
Н					
1					
J					
М

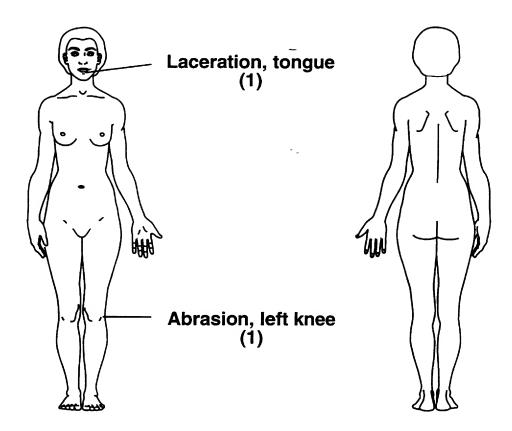
## INDICATE LOCATION OF INJURIES.

Injury Source	
Injury Description	A.I.S.	Definite	Probable	Possible
Laceration, tongue	1	Bit with teeth		
Abrasion, left knee	1	Knee bolster		
Maximum A.I.S. Level	1		,	
Injury Severity Score	2			1
	_
